## **Maryland Historical Trust**

MARYLAND INVENTORY OF HISTORIC BRIDGES HISTORIC BRIDGE INVENTORY MARYLAND STATE HIGHWAY ADMINISTRATION/MARYLAND HISTORICAL TRUST

MHT No. <u>BA-2850</u>

SHA Bridge No. B0072 Bridge name Dogwood Road over Dogwood Run (Dogwood Road Bridge)
LOCATION: Street/Road name and number Dogwood Road
City/town Hollofield Vicinity X
County Baltimore
This bridge projects over: Road Railway Water X Land
Ownership: State County X Municipal Other
HISTORIC STATUS:  Is bridge located within a designated historic district? Yes No _X_  National Register-listed district National Register-determined-eligible district  Locally-designated district Other
Name of district
BRIDGE TYPE: Timber Bridge: Beam Bridge Truss -Covered Trestle Timber-And-Concrete  Stone Arch Bridge
Metal Truss Bridge
Movable Bridge: Swing Bascule Single Leaf Bascule Multiple Leaf Vertical Lift Retractile Pontoon
Metal Girder:  Rolled Girder:  Rolled Girder Concrete Encased  Plate Girder:  Plate Girder:
Metal Suspension
Metal Arch
Metal Cantilever
Concrete X: Concrete Arch X Concrete Slab Concrete Beam Rigid Frame

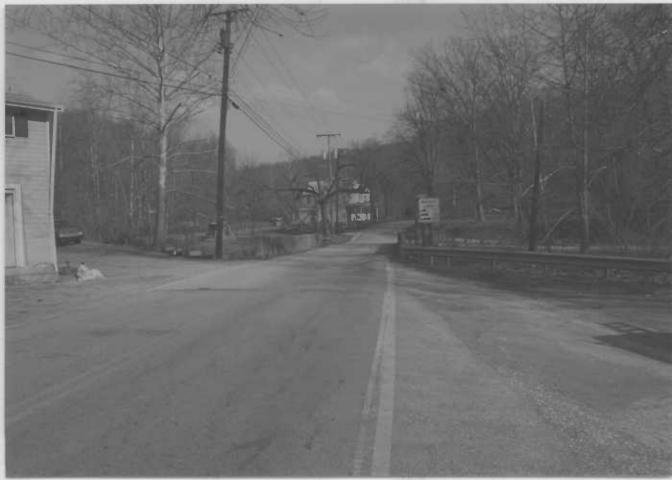
## Inventory # BA - 2850

N BID 77-	DOG WADDIO	RD OVER DOG	WOOD RUN
County/State	BALTIMO	DRE COUNTY /	MD
Name of Phot	ographer 1	DAVE DIEH	
Date	<u></u>		
Location of N	egative	SHA	
Description _	SOUTH	APPROACH	WOKING
Number 1	6	THE VENEZIE

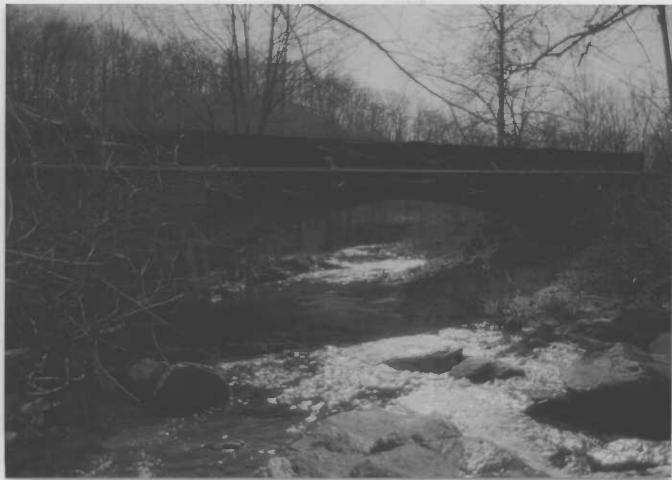
Inventory # BA-2856
Name 80072-DOGWWO RO OVER DOGWOOD RUN
County/State BALTIMORE COUNTY/MO
Name of Photographer DAVE DIEHL  Date 1/95
Location of Negative SHA
Description WEST ELEVATION LOOKING

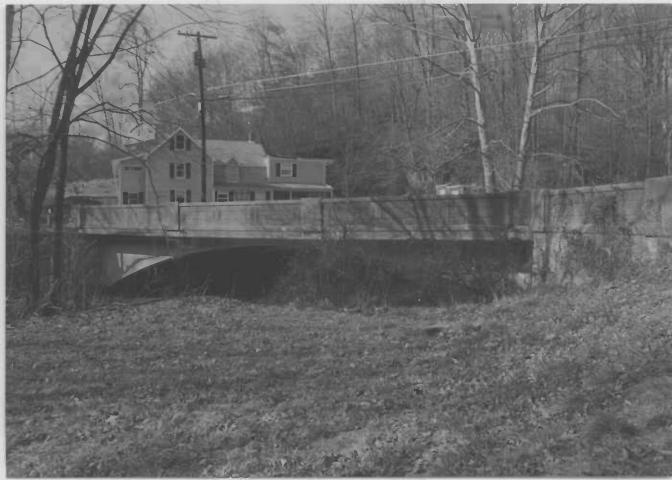
Name Bun 2 County/State Name of Pho Date 1 9	BALTIMORE tographer	RD WER COUNTY AVE DI	DOGWOOD RYN EHL
	Negative 51		
Description	EAST EL SOUTHWES	EVATIO	N LOOKING

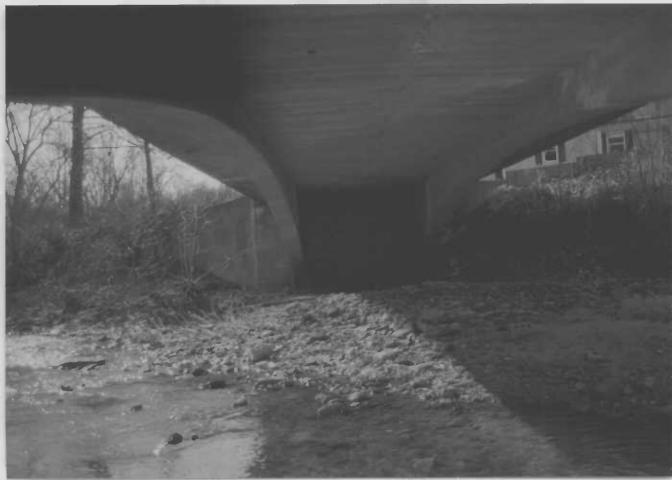
Name BOOT 2-DOGWOOD RD OVER DOWDOD RUN County/State BALTIMORE COUNTY/MO
Name of Photographer DAVE DIENL Date 195
Location of Negative SHA
Description UNDERSIDE OF DECK LOUKING South
Number 48 of 39

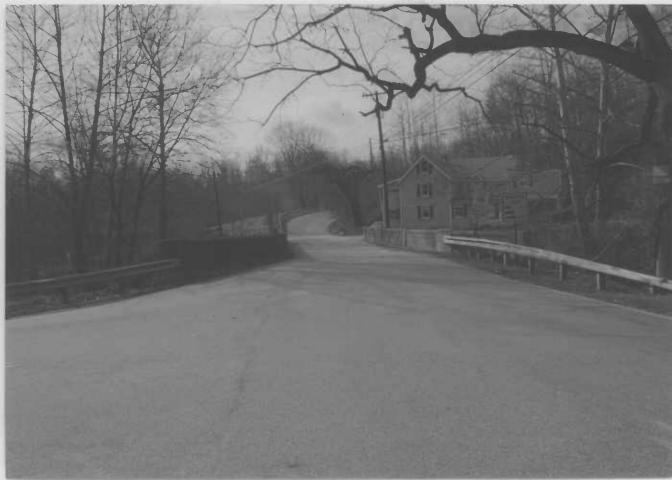
Description NORTH APPROACH WORING
South
